Tree Protection Action Key (TPAK)

MARET SCHOOL
PROPOSED ATHLETIC FIELDS
CORNER OF UTAH AVE NW &
NEBRASKA AVE NW
WASHINGTON, D.C. 20015

SITE UTILITY PLAN

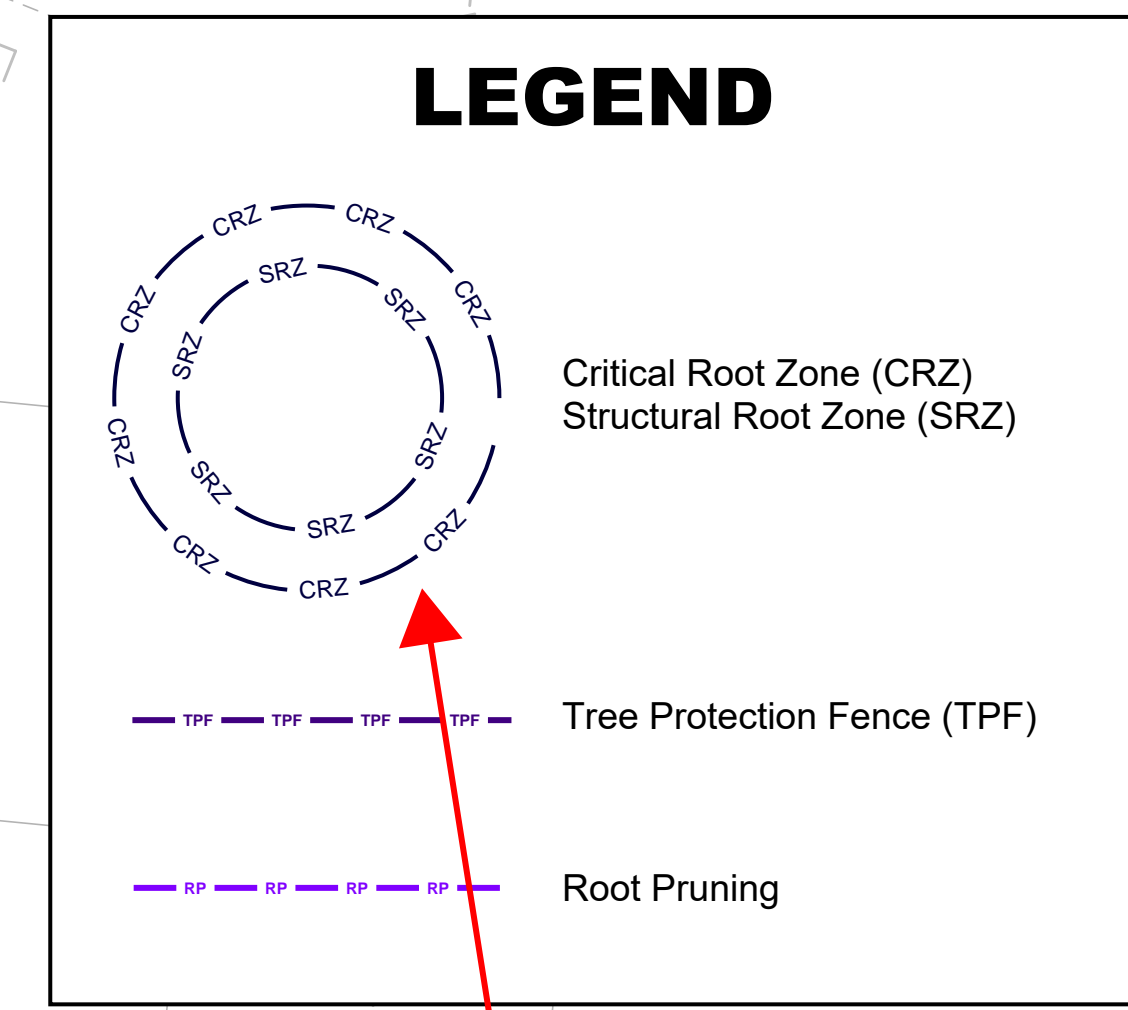
Note: Critical root zone

The impervious parking lot and the soil compaction required for the construction of the lot is likely to distress these two heritage trees intended to be saved. Urban Forestry on 2/16/2022 was clear in the meeting, that any disturbance is not good for the trees.
