## **MEMORANDUM**

SUBJECT: 1900 Half Street, SW: Floodplain Mitigation Alternative Construction Methods

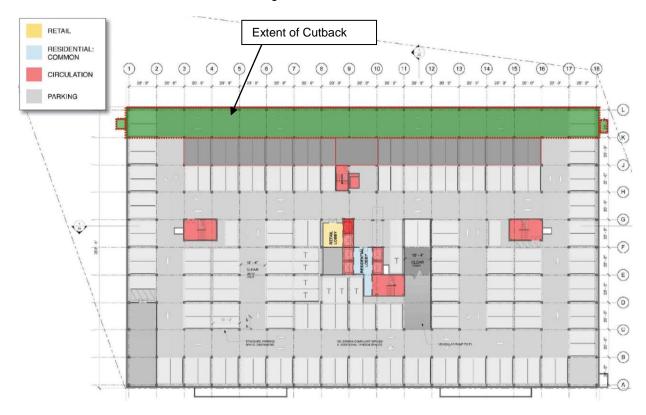
1. **P2 Level** – Loss of 6,800sf of existing cellar area.

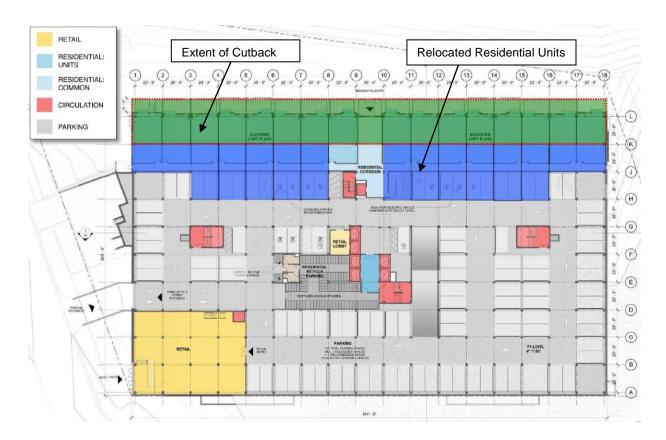
2. **P1 Level** - Reduction of residential units (at elevated floor) from 16 to 13, and loss of 6,800sf of basement space.

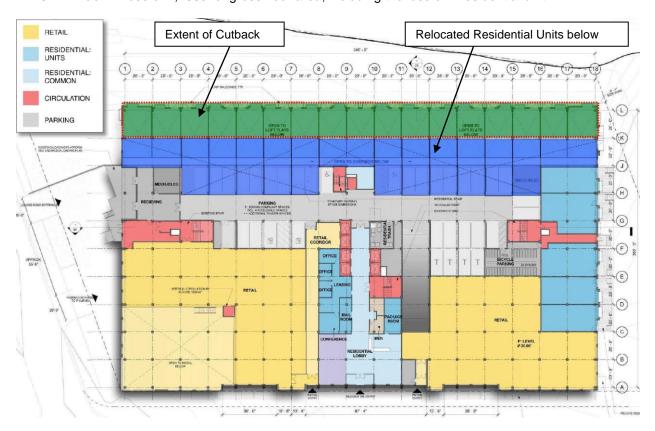
3. 1st Floor – Loss of 4,400sf of gross floor area, including the loss of 1 residential unit.

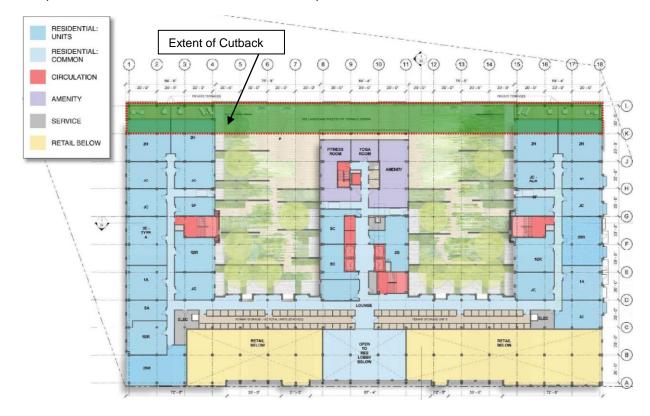
4. **2<sup>nd</sup> Floor** – Loss of 6,800sf of gross floor area. The connection between the north and south public terraces will be lost and loss of 1,200sf private terrace area.

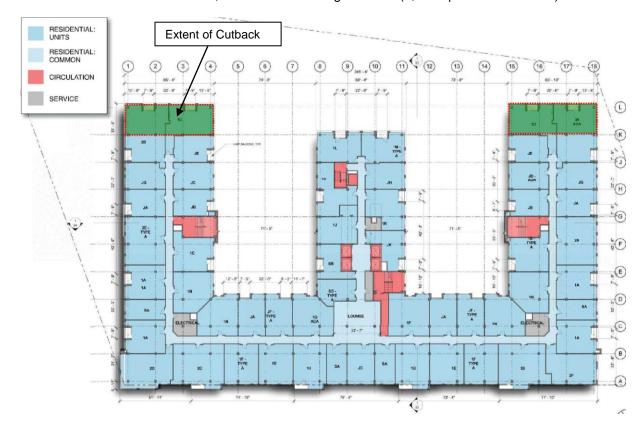
5. **3**<sup>rd</sup> **to 6**<sup>th</sup> **Floor** – Loss of 9,600sf of residential gross floor (2,400ft per floor x 4 floors).

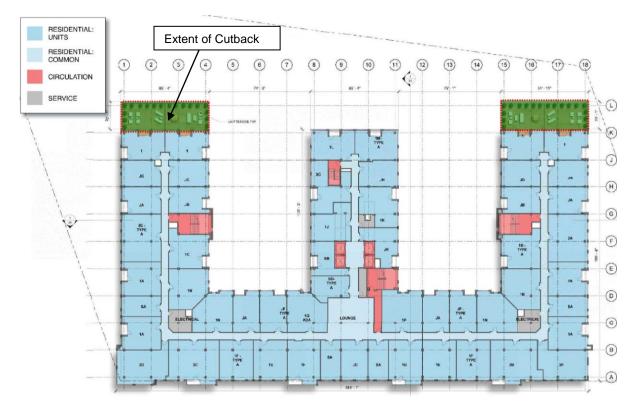
6. 8th Floor – Loss 2,400sf of private terraces on the east side
