508 Rhode Island Ave NW  
Washington, DC 20001  
owner: Pouria Saldi & Dona Faknejad

Date: 1.9.15  
Issue/revision:  
Preliminary Bid Set

Site Plan &  
Site Photos

A-1.0

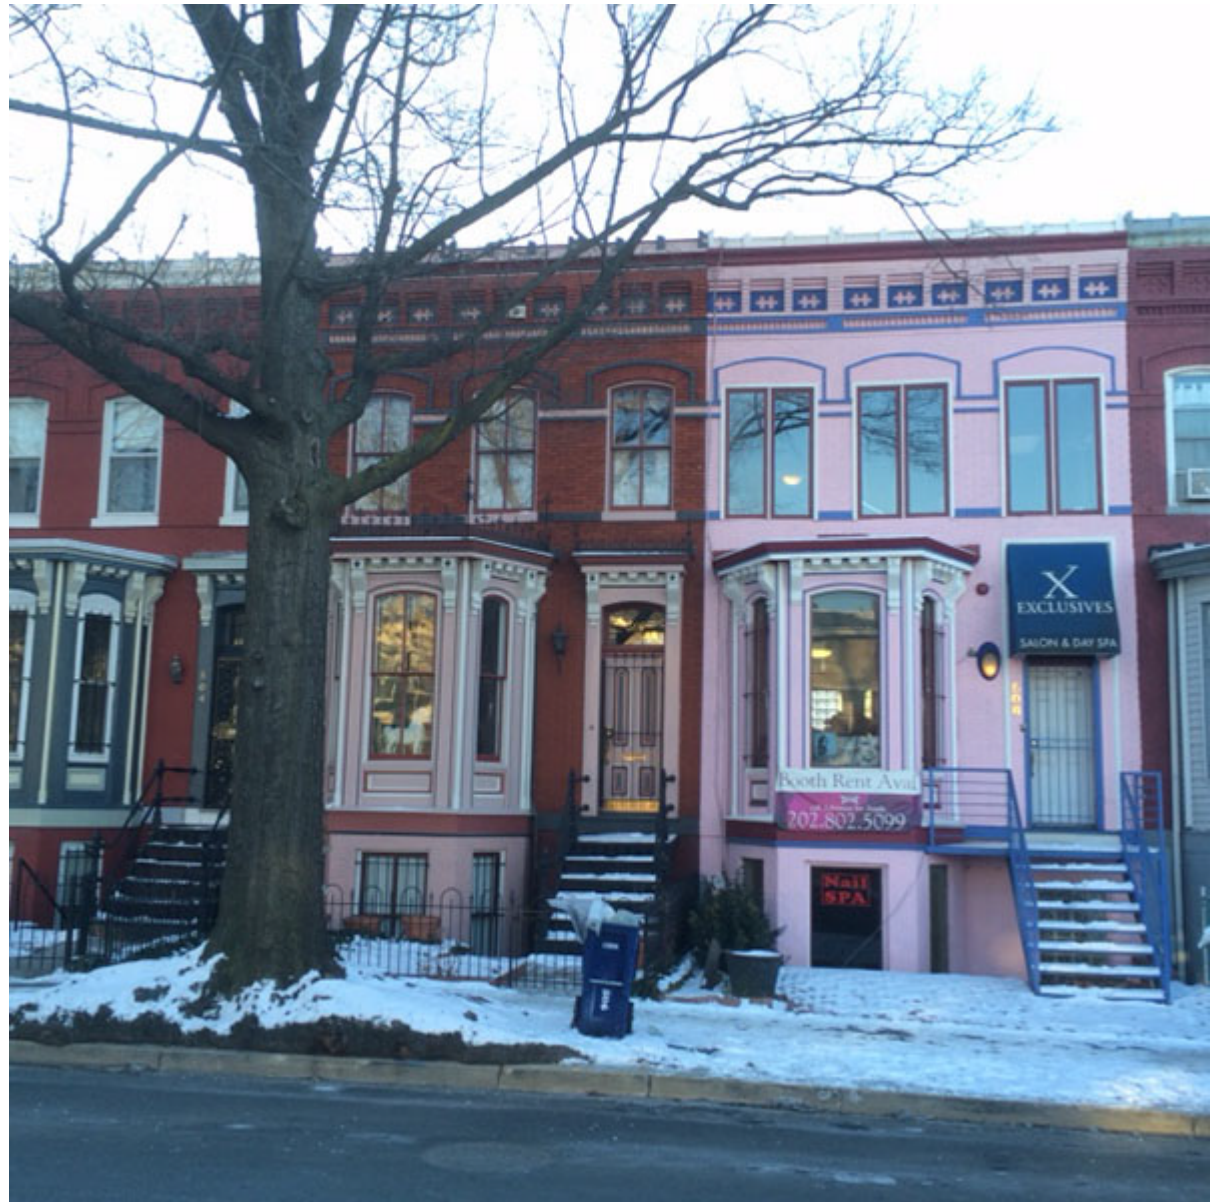
EXISTING FRONT VIEW OF BUILDING SHOWING NEIGHBORS TO THE EAST

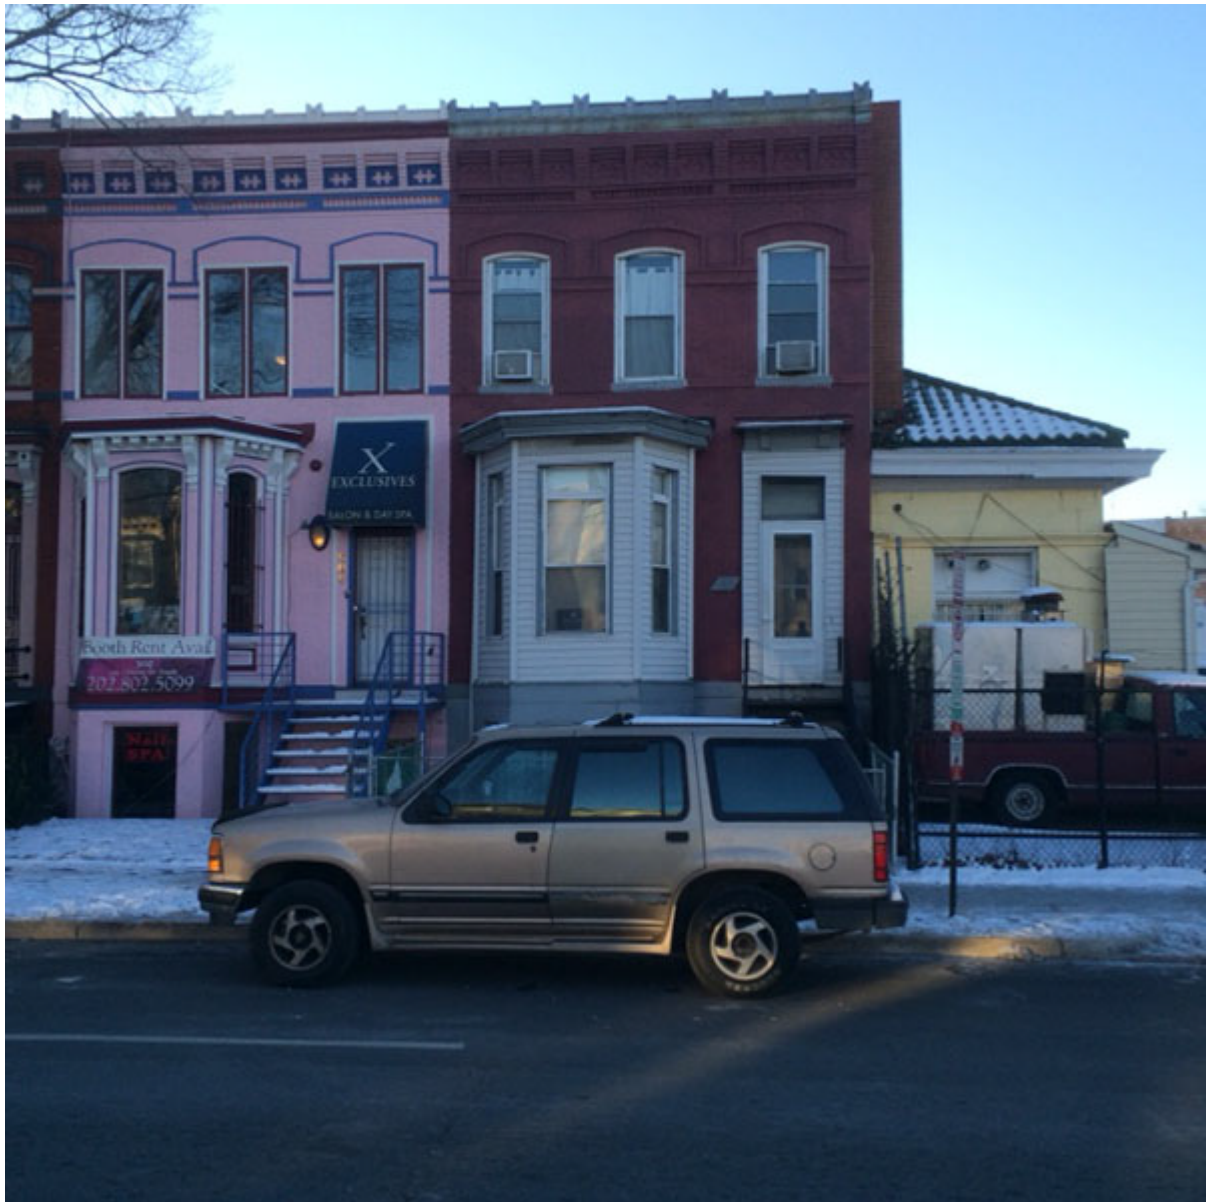
EXISTING FRONT VIEW OF BUILDING SHOWING NEIGHBORS TO THE WEST

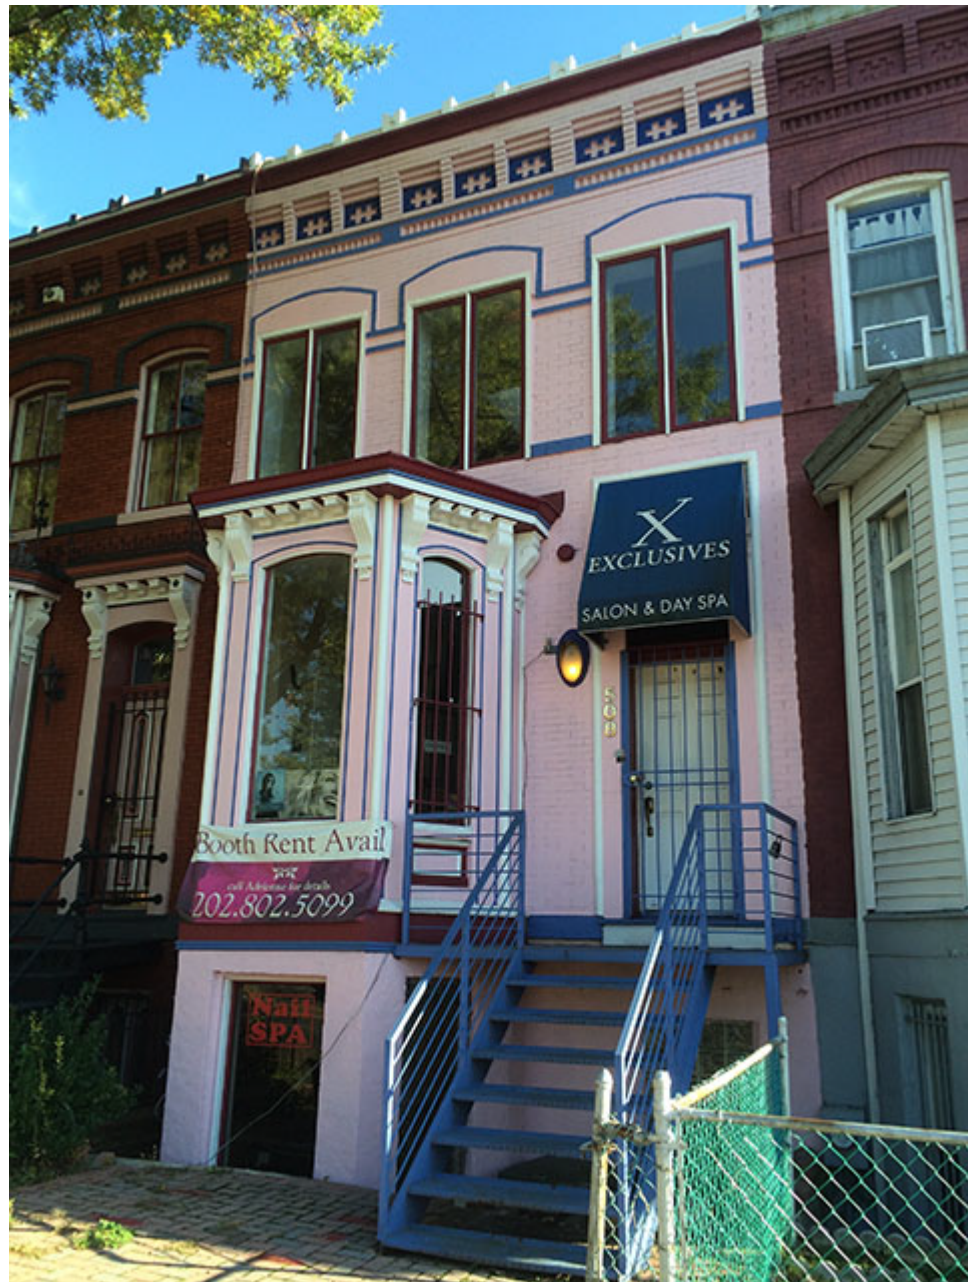
EXISTING FRONT VIEW OF BUILDING

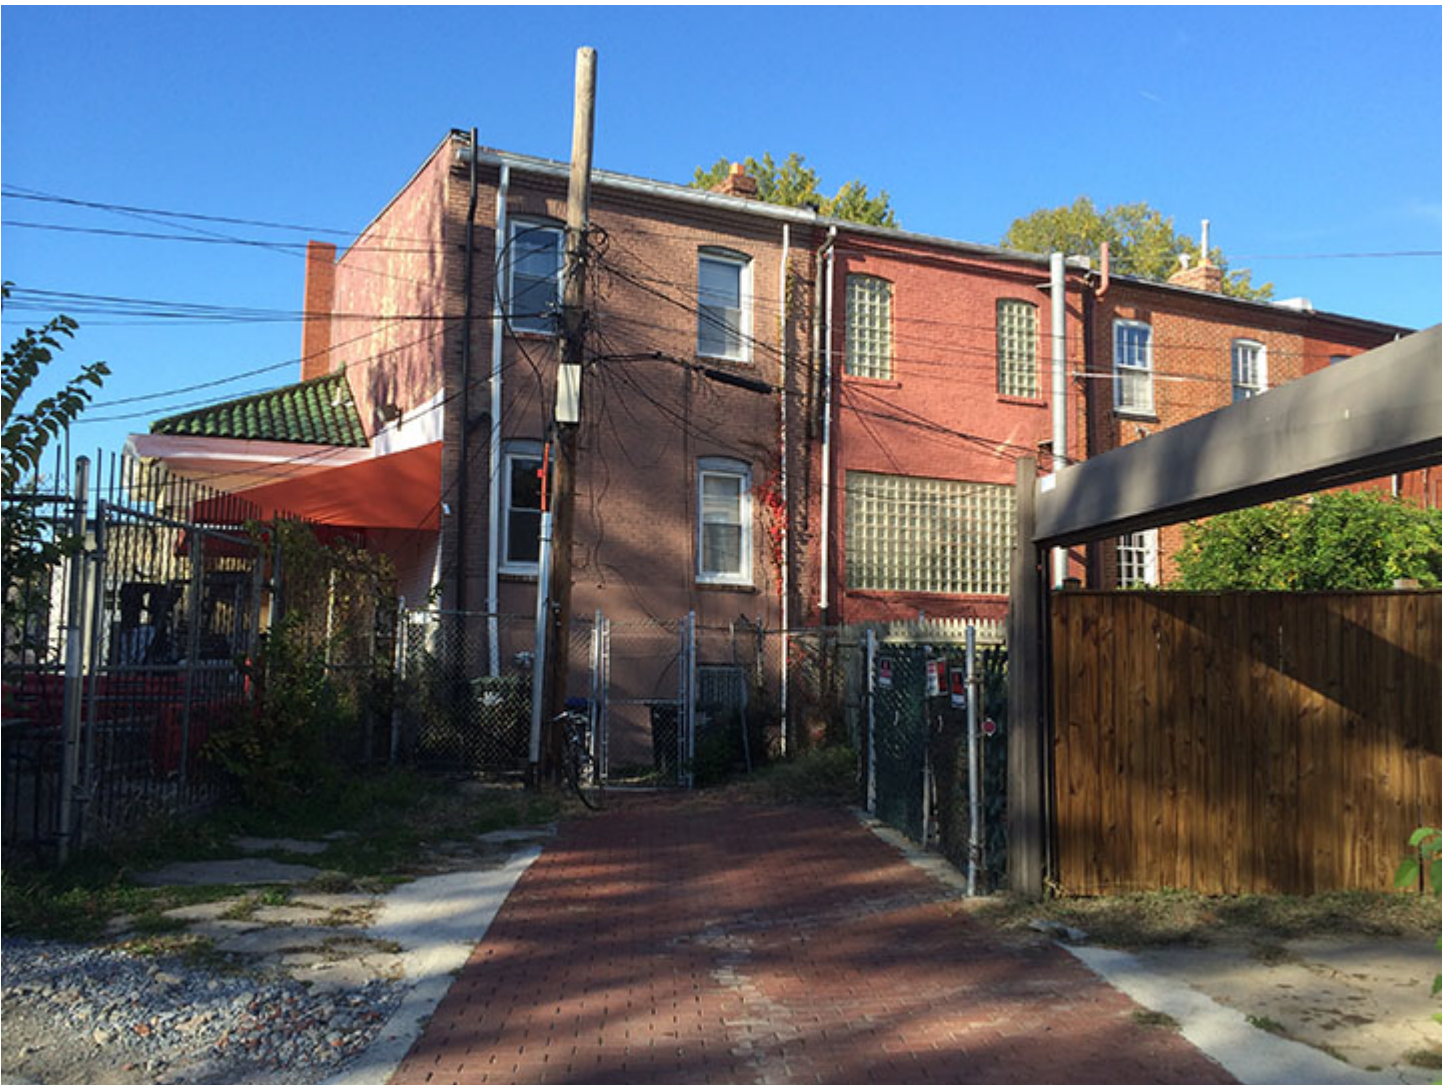
EXISTING REAR VIEW OF BUILDING SHOWING NEIGHBORS
