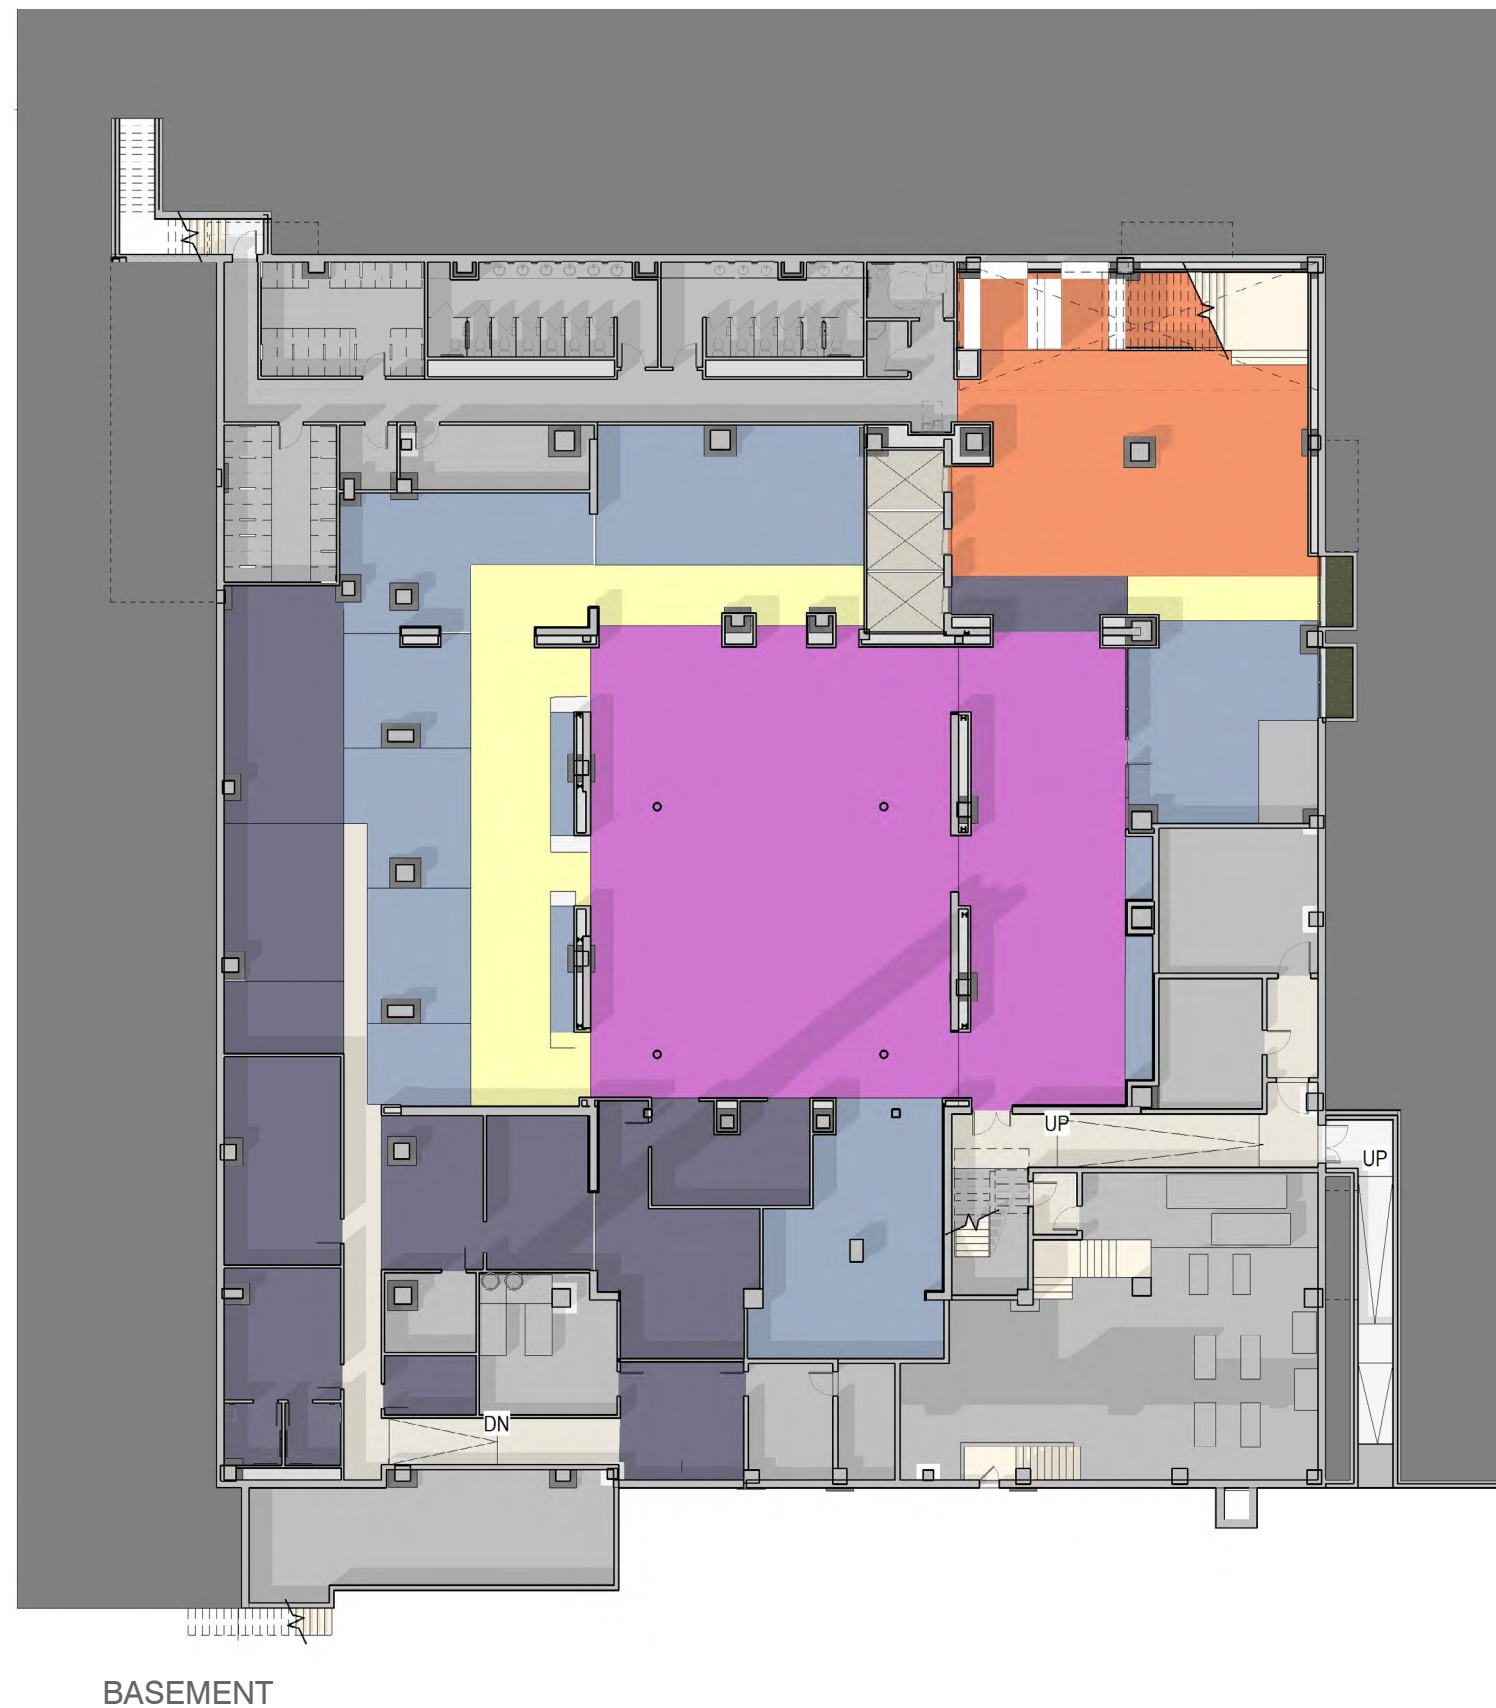
BASEMENT

- DINING SEATING
- DINING SERVING
- DINING PREPARATION
- DINING SERVING CIRCULATION
- BUILDING CIRCULATION
- BUILDING SUPPORT
- BEDROOM
- APARTMENT
- OFFICE SUITE
- LOUNGE / STUDY
- COMMON

size and configuration of interior spaces is conceptual only and subject to change

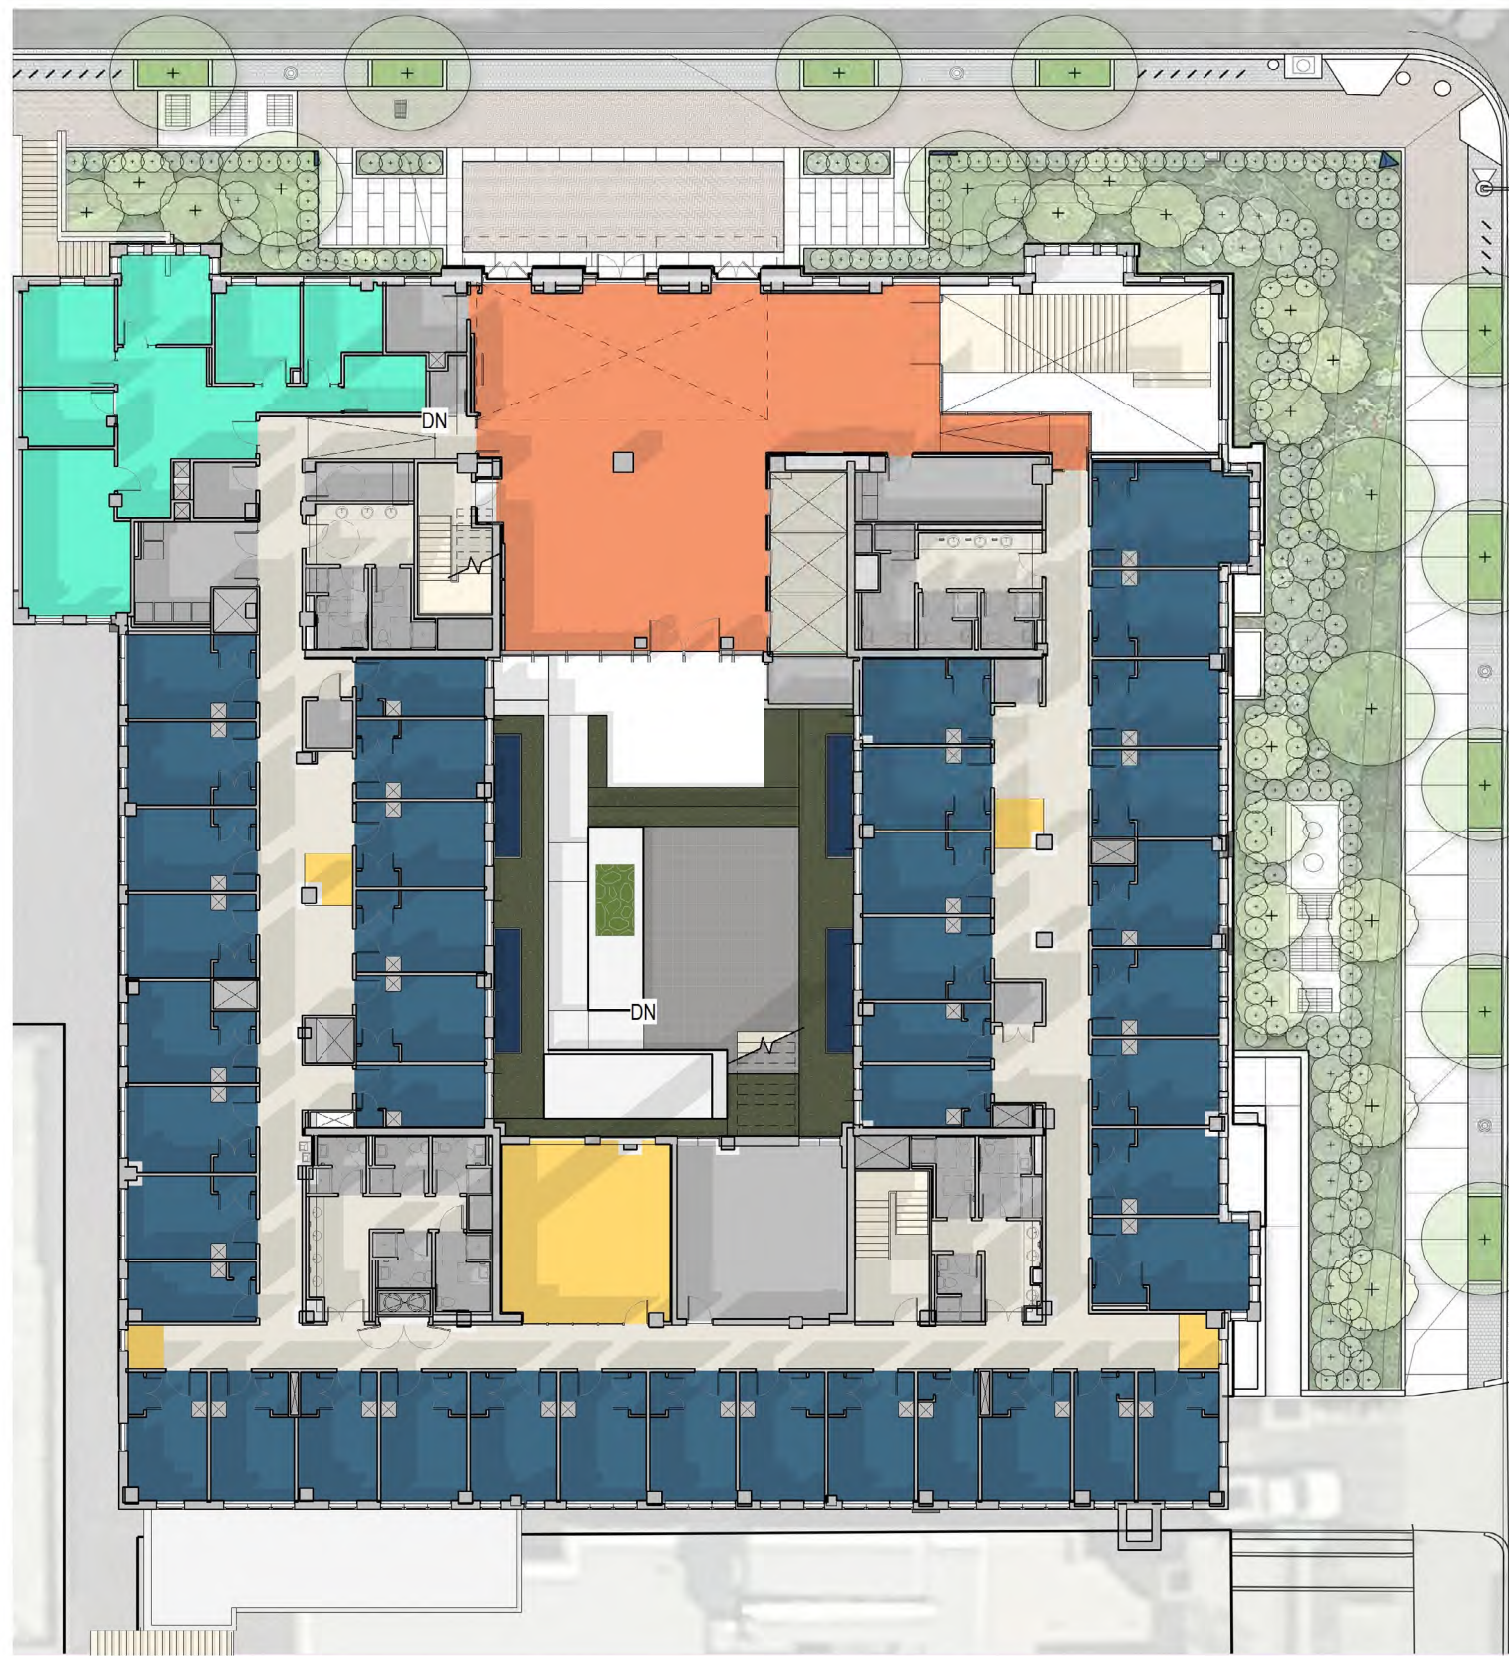
FIRST FLOOR

- DINING SEATING ■
- DINING SERVING ■
- DINING PREPARATION ■
- DINING SERVING CIRCULATION ■
- BUILDING CIRCULATION ■
- BUILDING SUPPORT ■
- BEDROOM ■
- APARTMENT ■
- OFFICE SUITE ■
- LOUNGE / STUDY ■
- COMMON ■

size and configuration of interior spaces is conceptual only and subject to change
