# Diagram of "Exterior Wall "3" - 4825 Dexter Terrace, NW

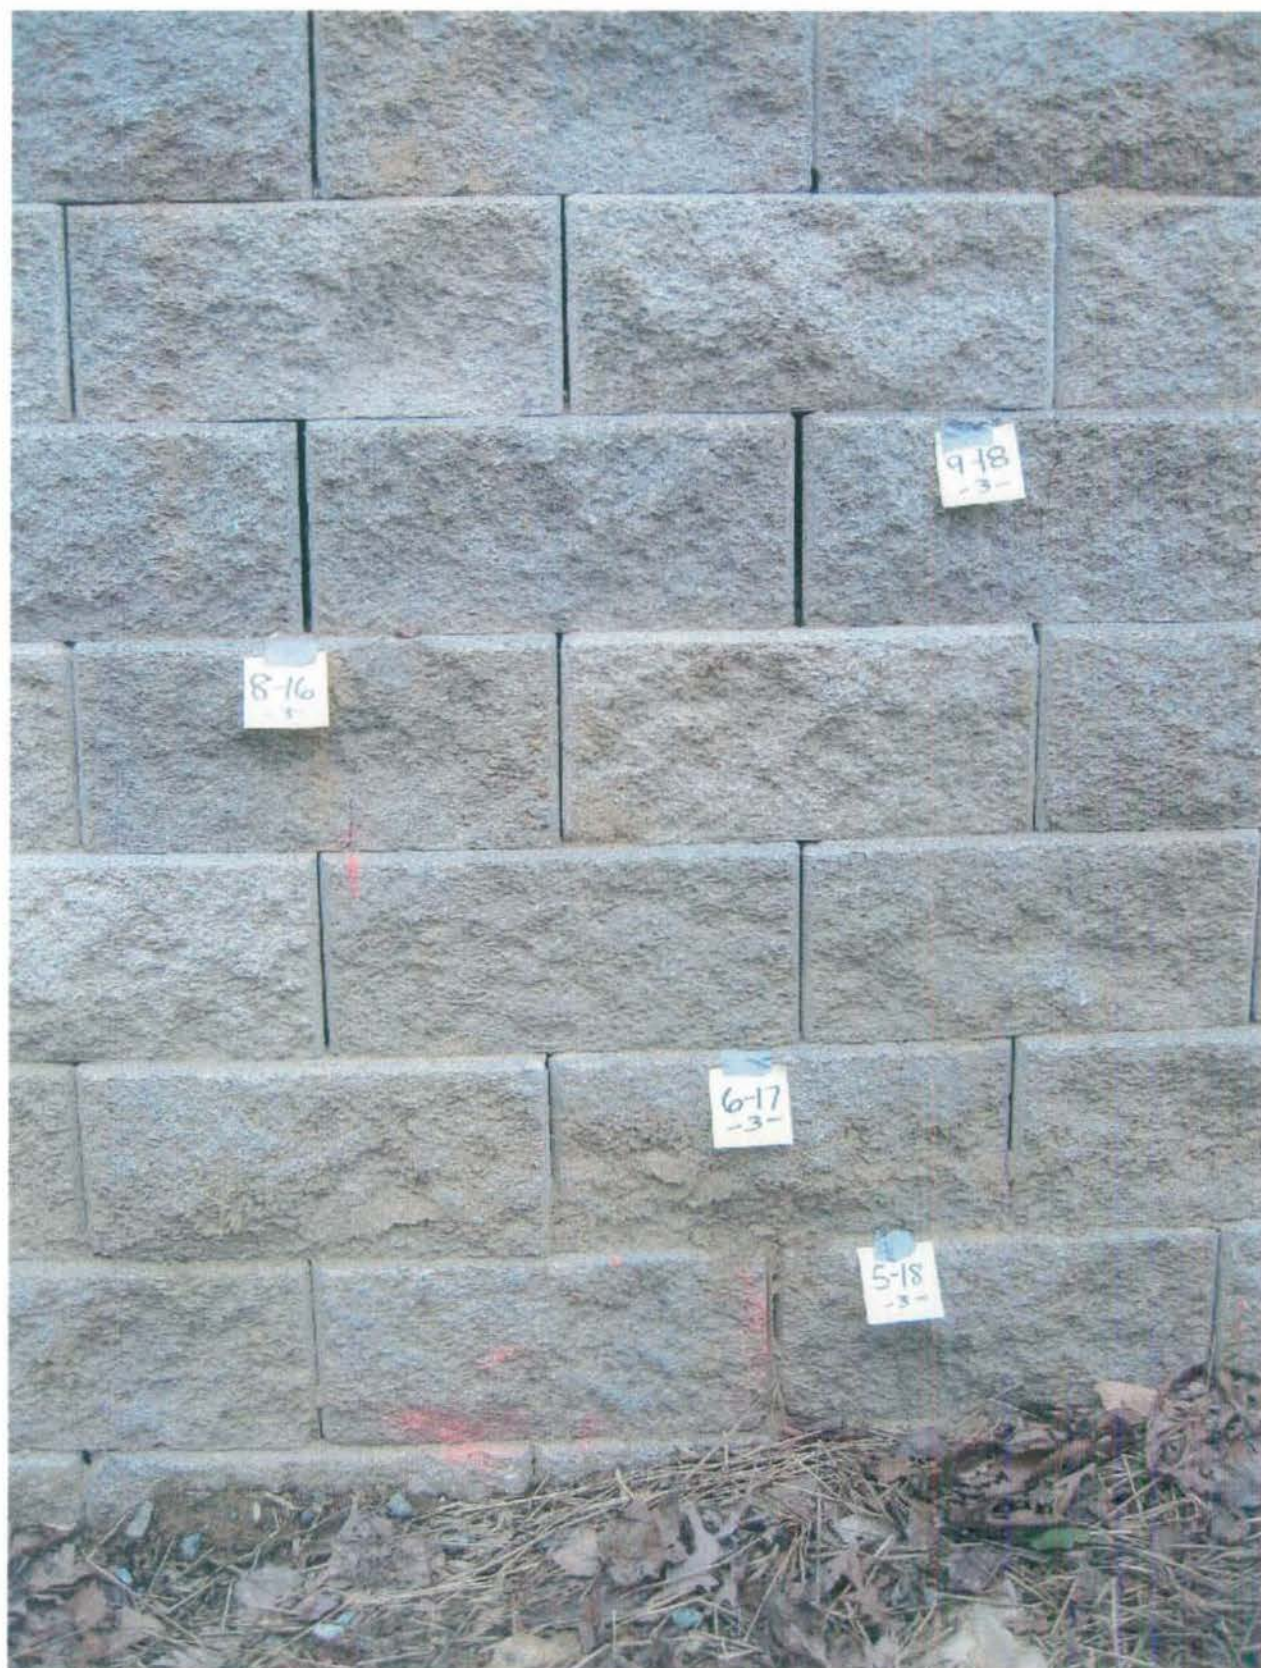
Damage in Wesley Heights Park from silt flowing  
from Economides' Walled Platform Structure.

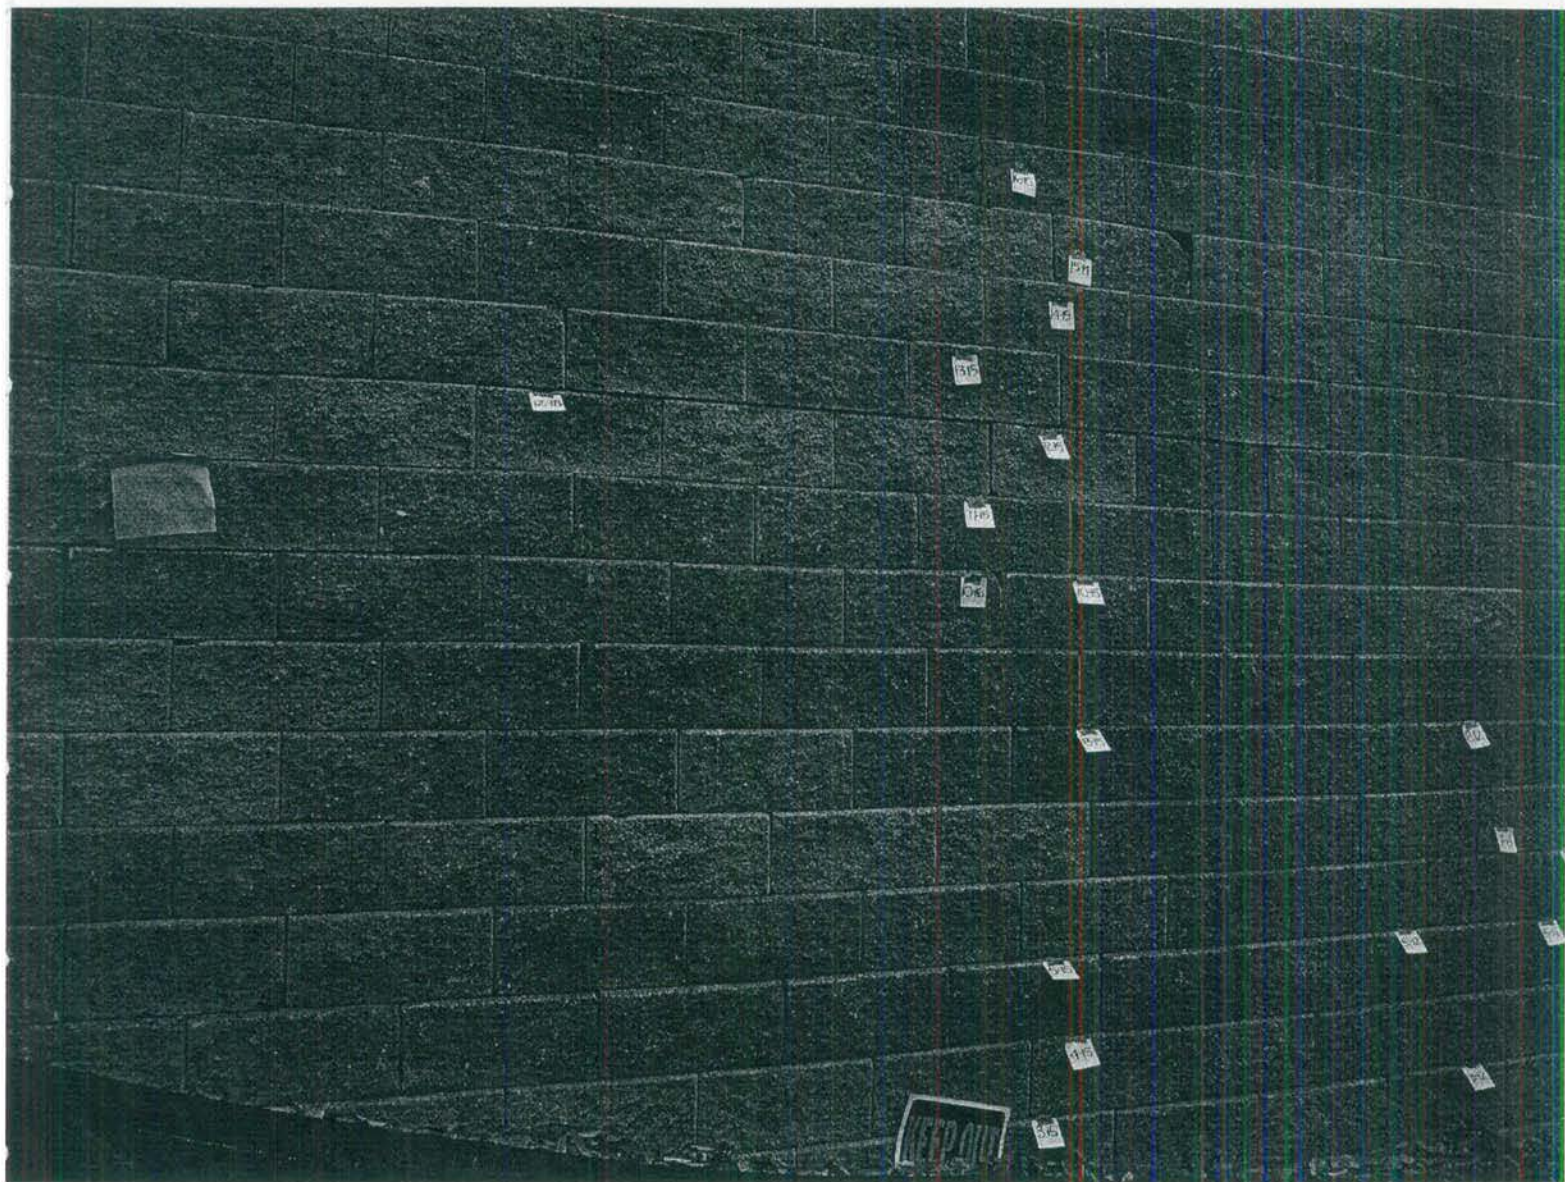
Examples of Cracks Developing Systemmatically  
in groups of mesa blocks (c 2/13/05)

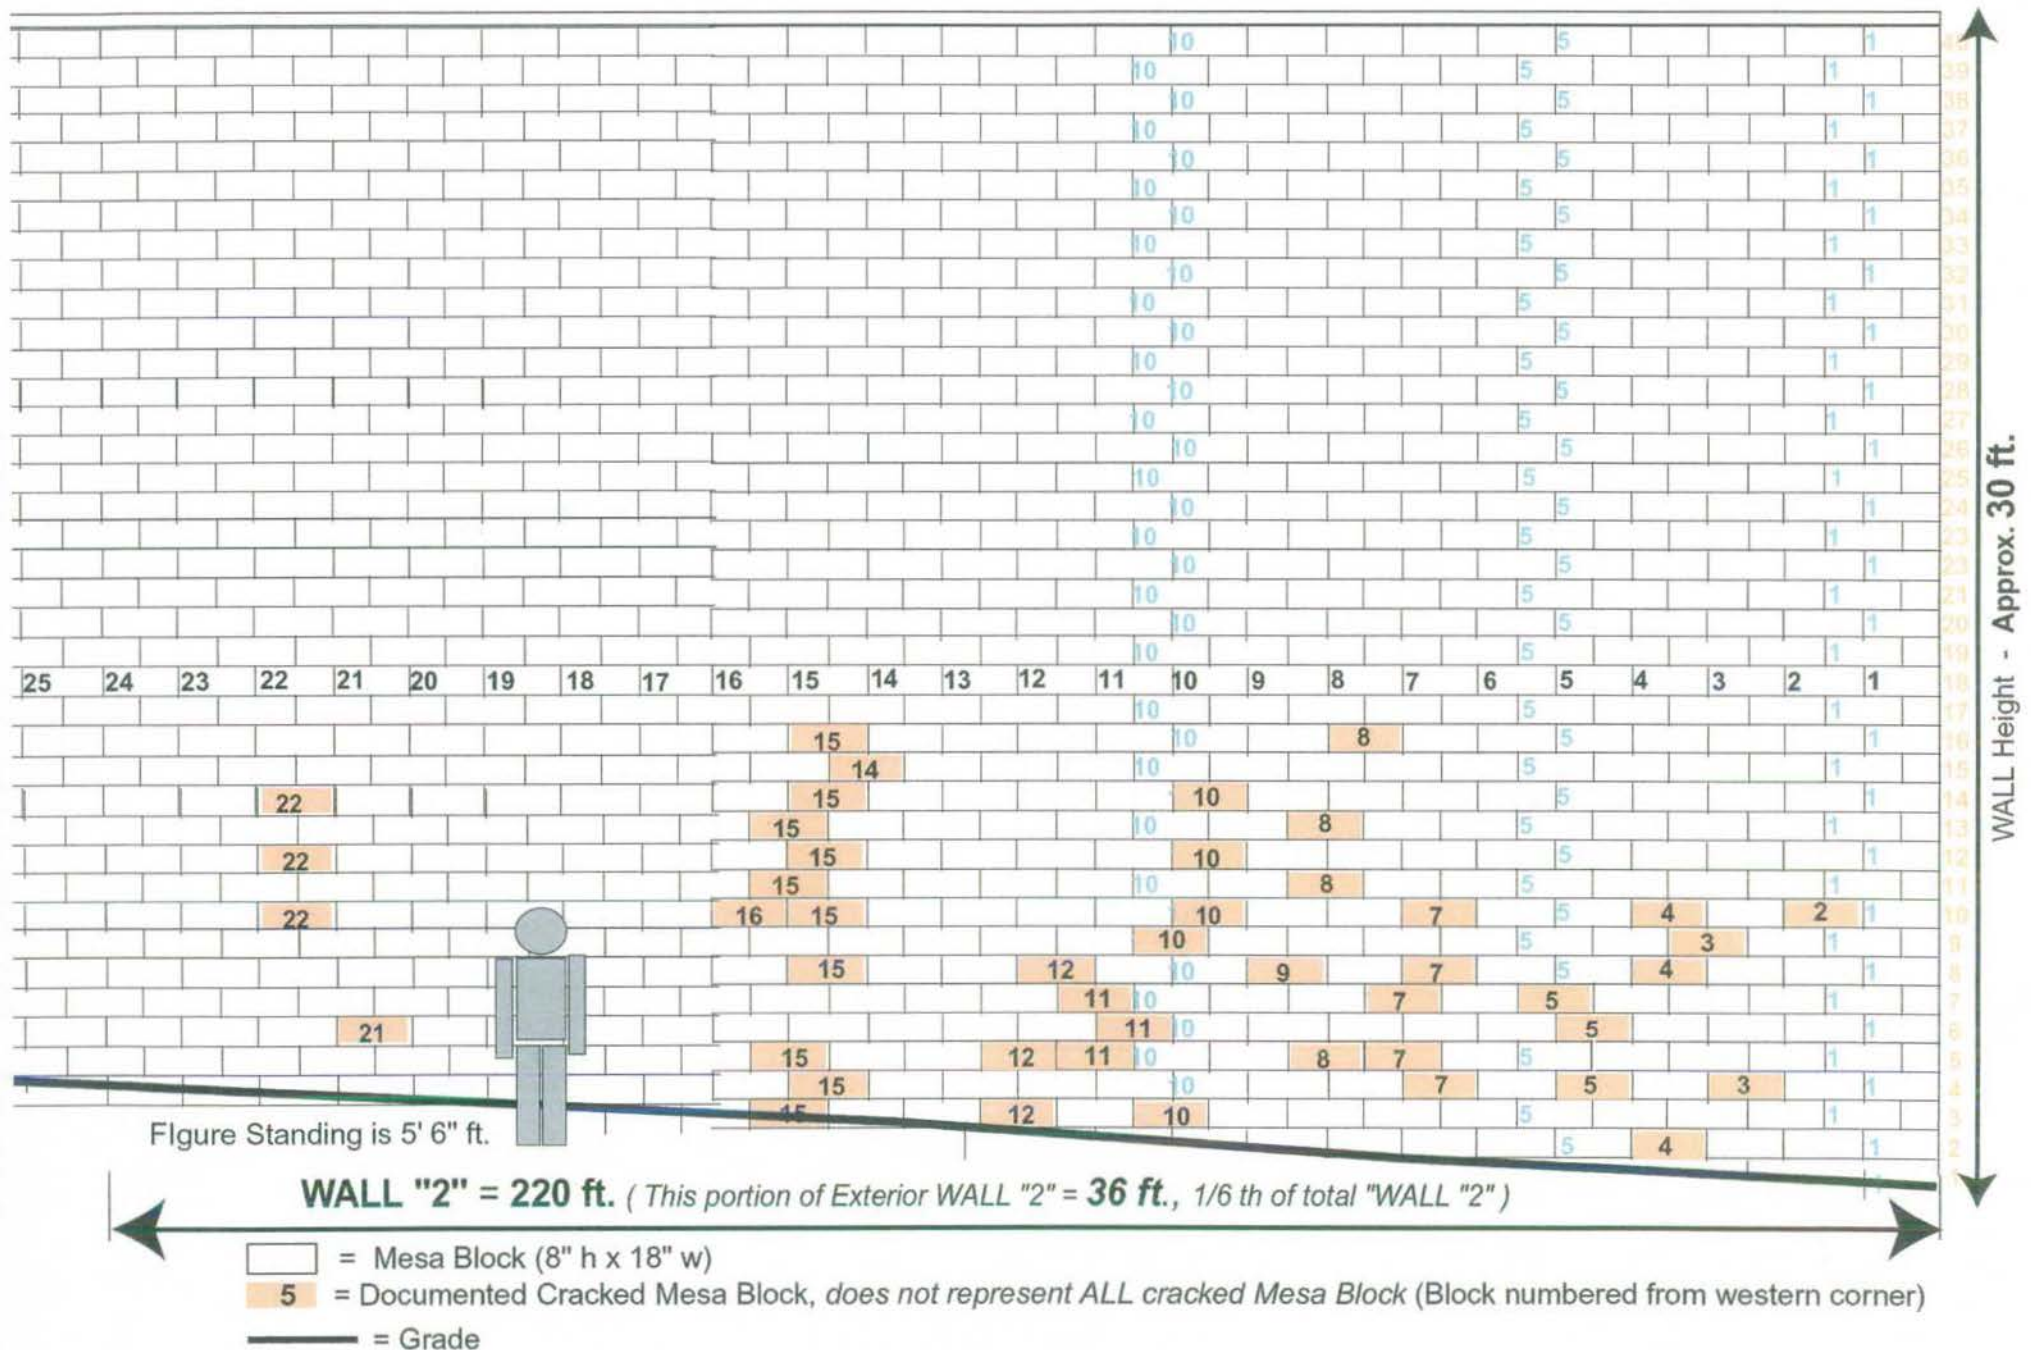
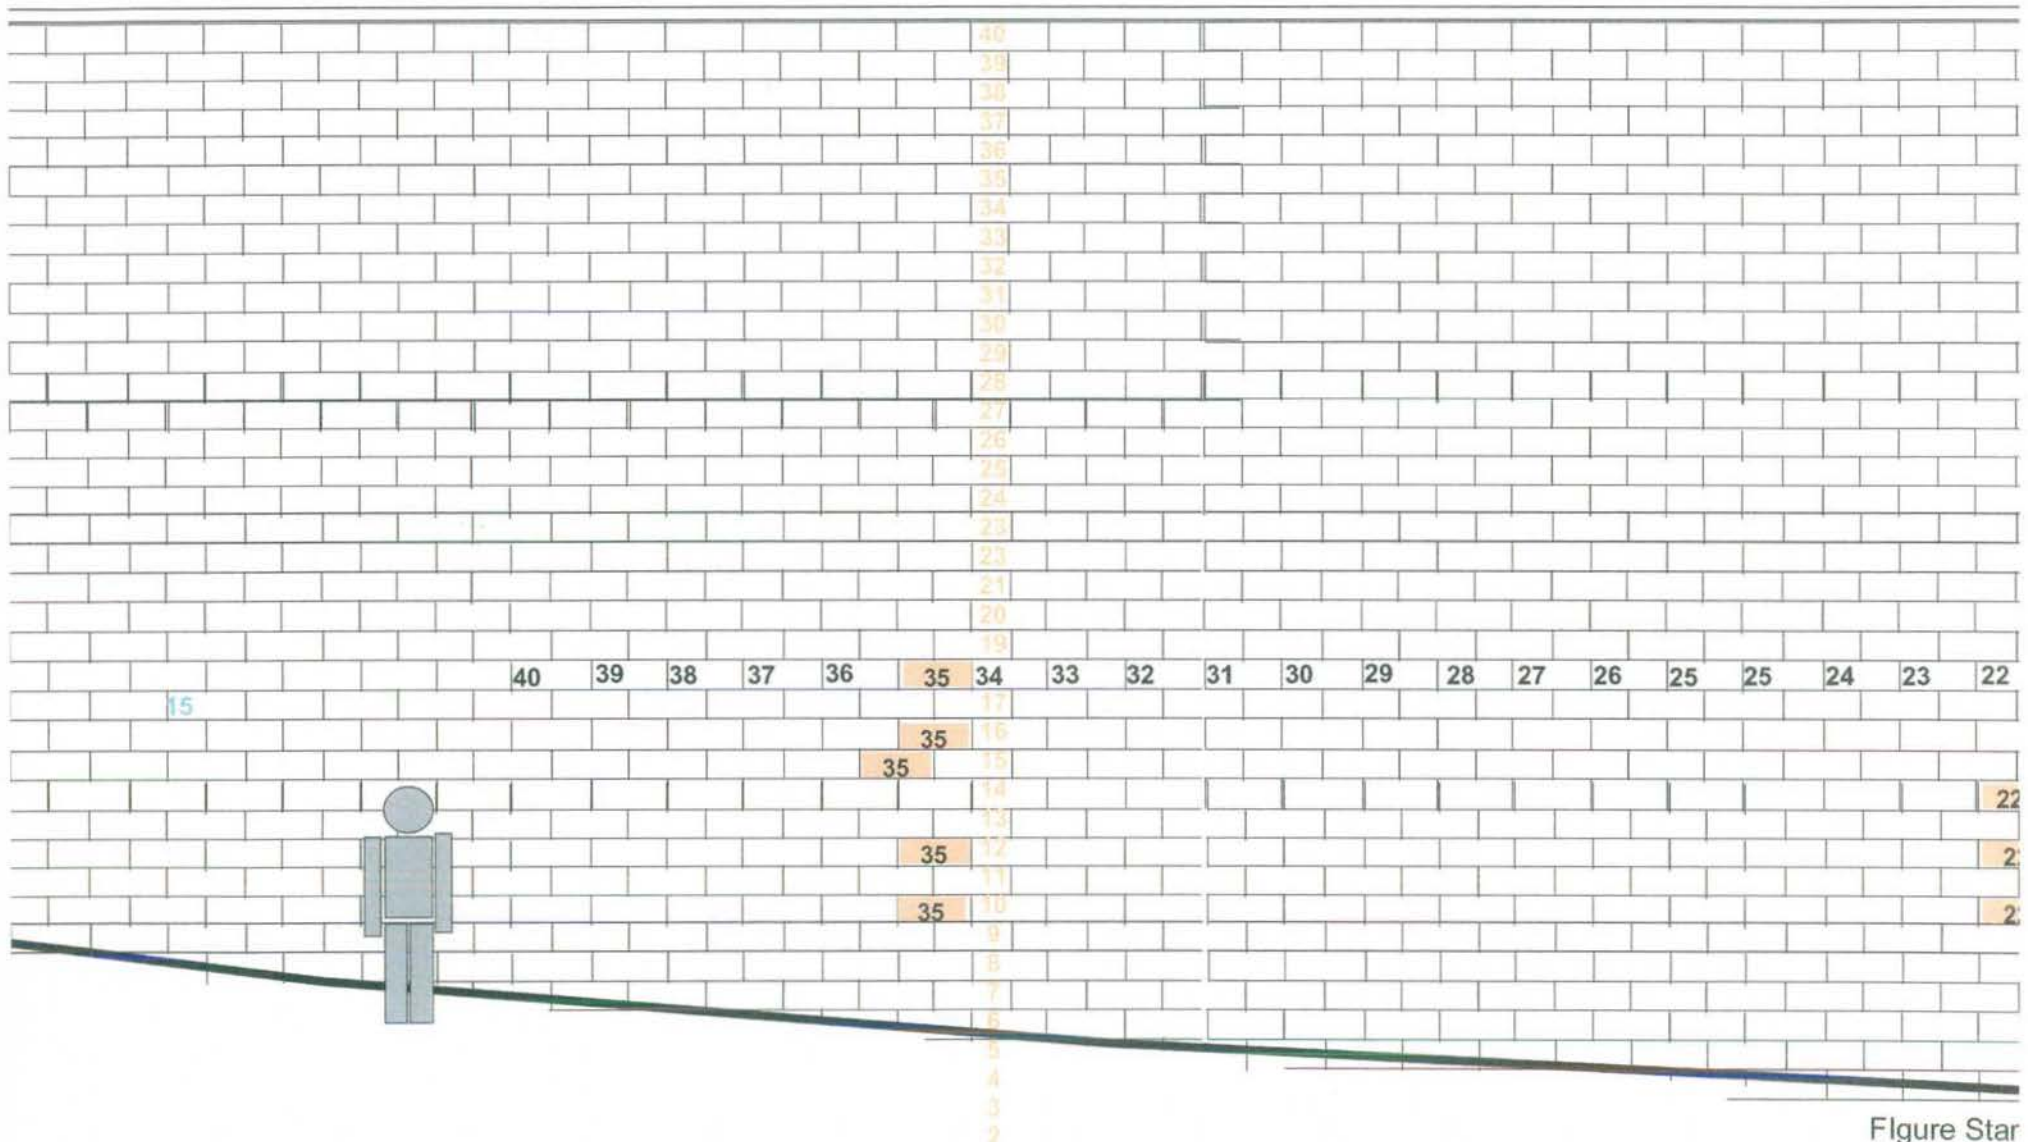
# 4825 Dexter Terrace, NW - Diagram of westernmost portion of "Exterior Wall "2"

WALL "2" = 220 ft. ( This portion of Exterior WALL "2" = 36 ft., 1/6 th of total "WALL "2" )

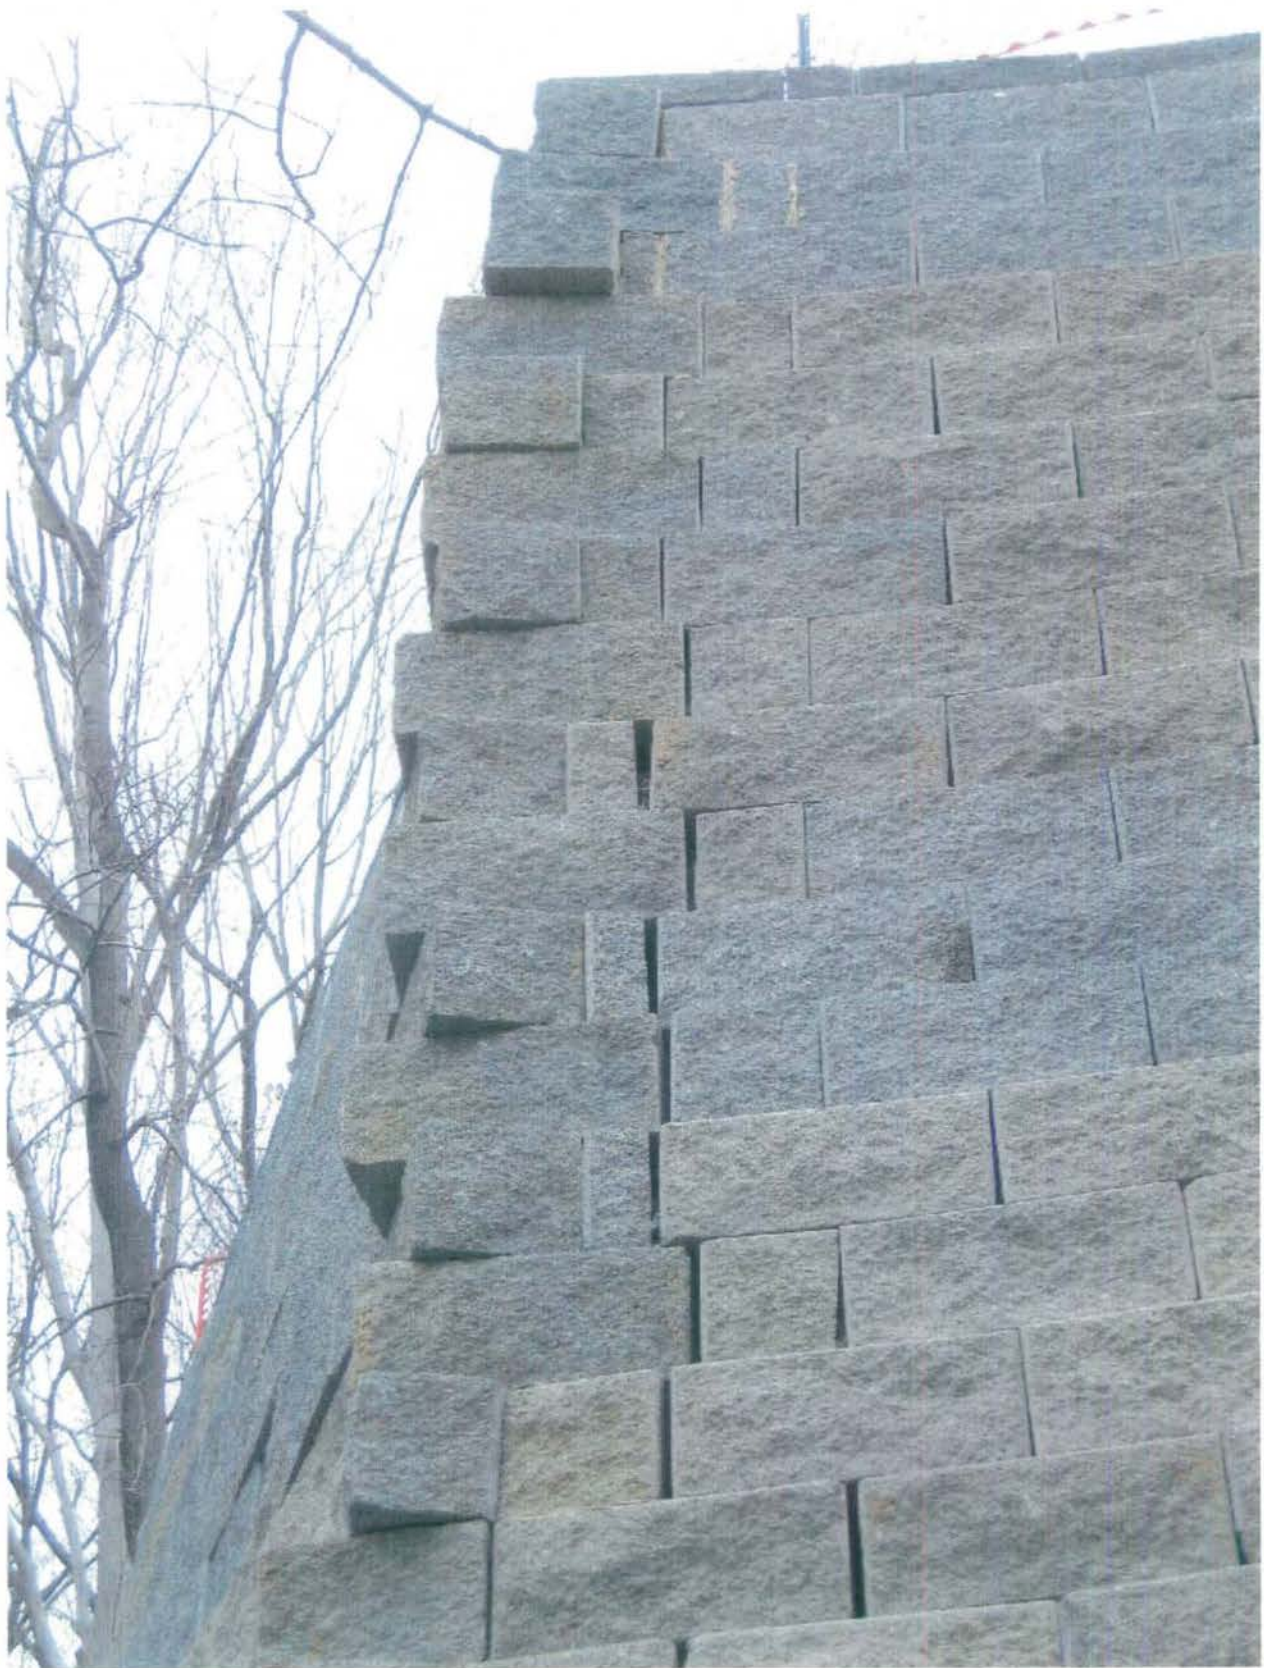
Examples of Separating Joints Between Walls

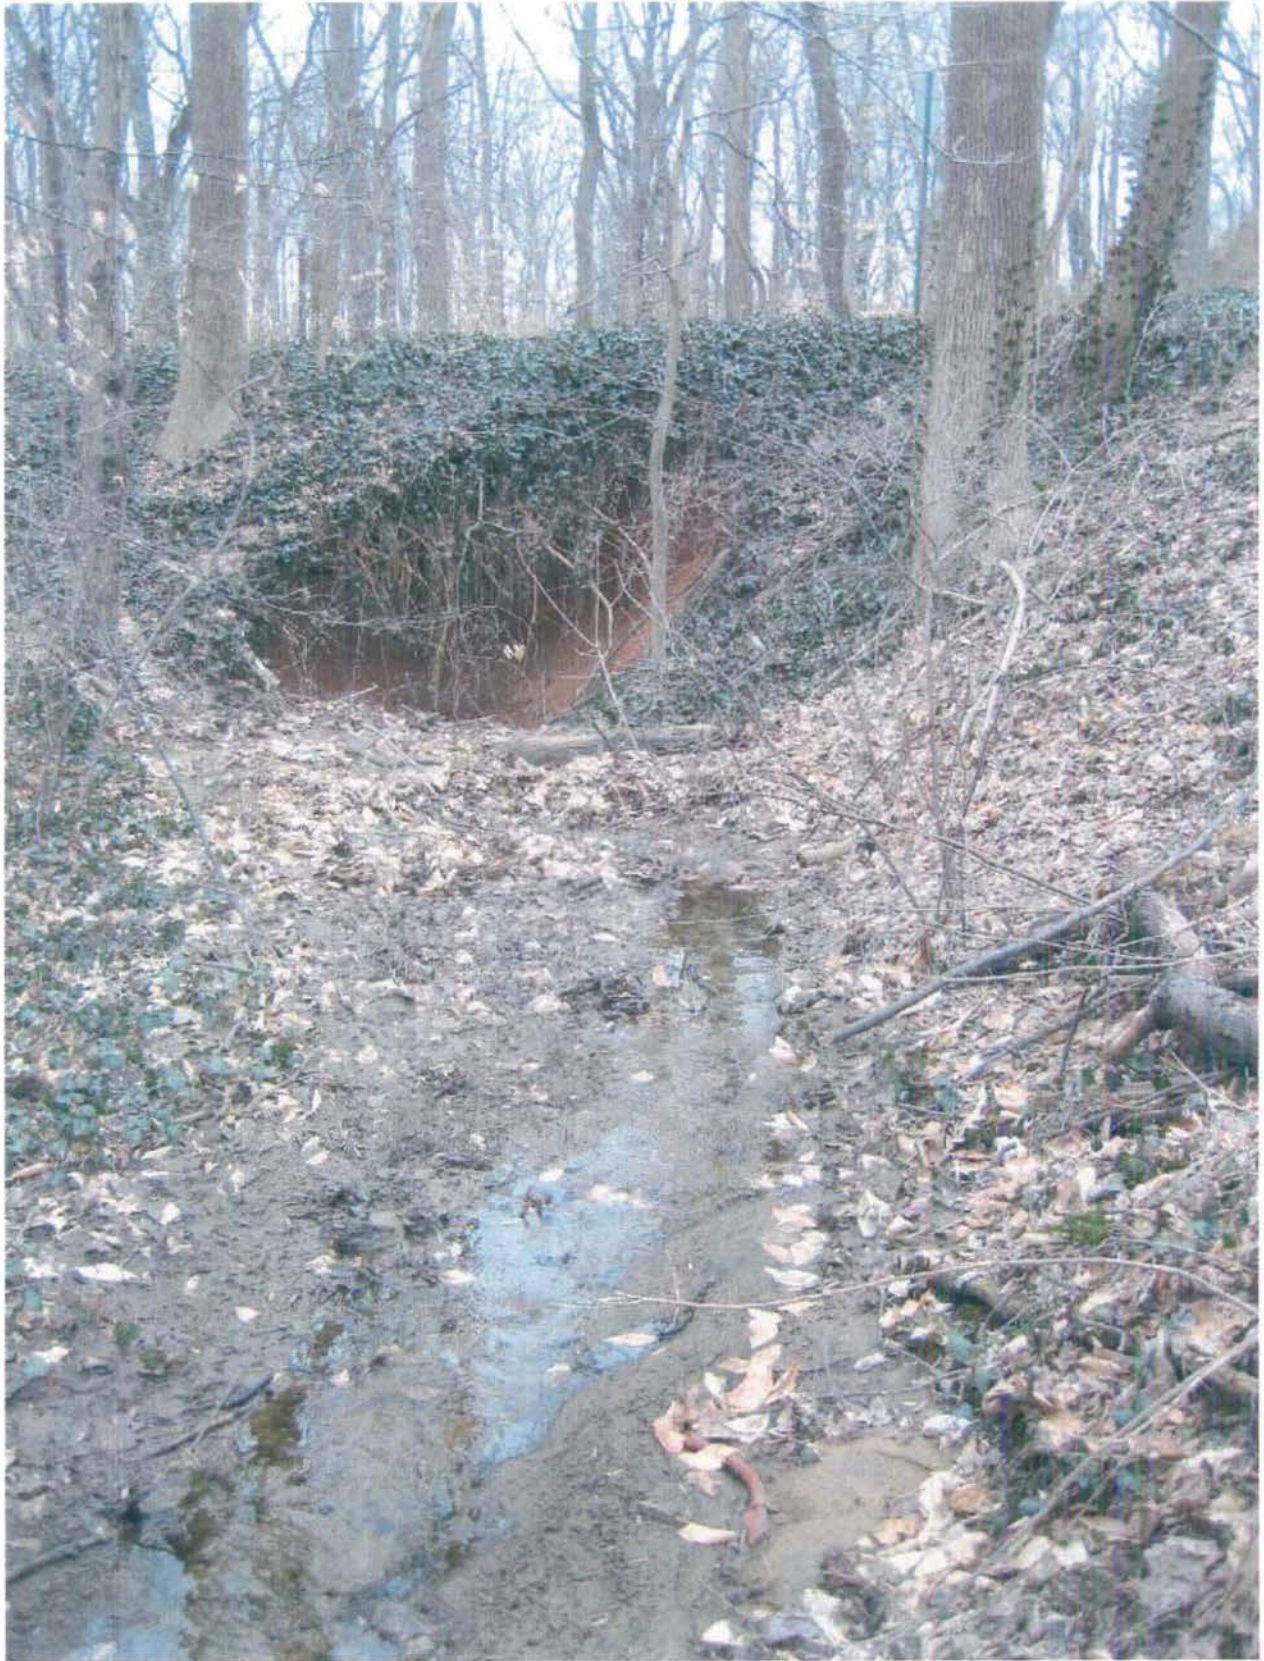
2-13-05- Collapsing tunnel that takes stream under  
49th St., N.W., from Wesley Heights Park  
to Battery Kimble Park - resulting from mud and  
silt flows from Economides wall structure.

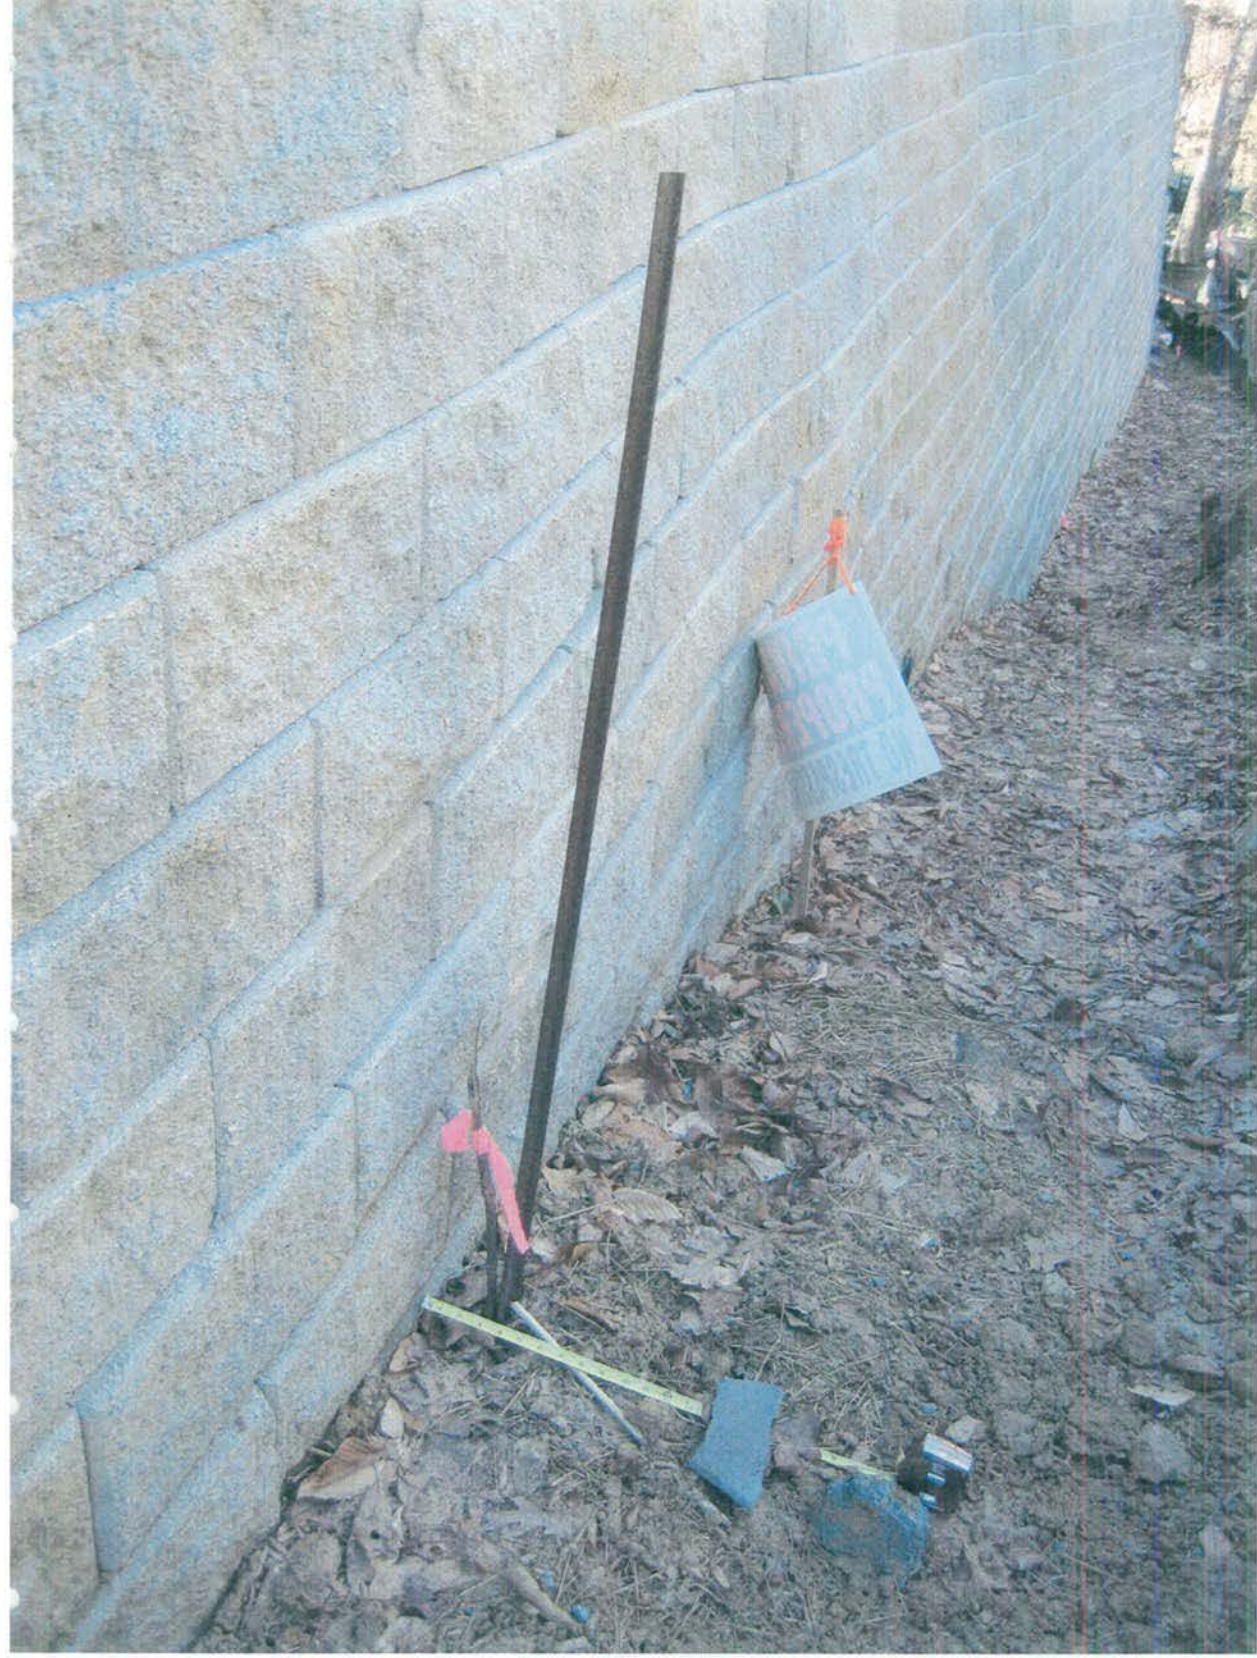
Photo Evidencing Wall's Encroachment on Parkland

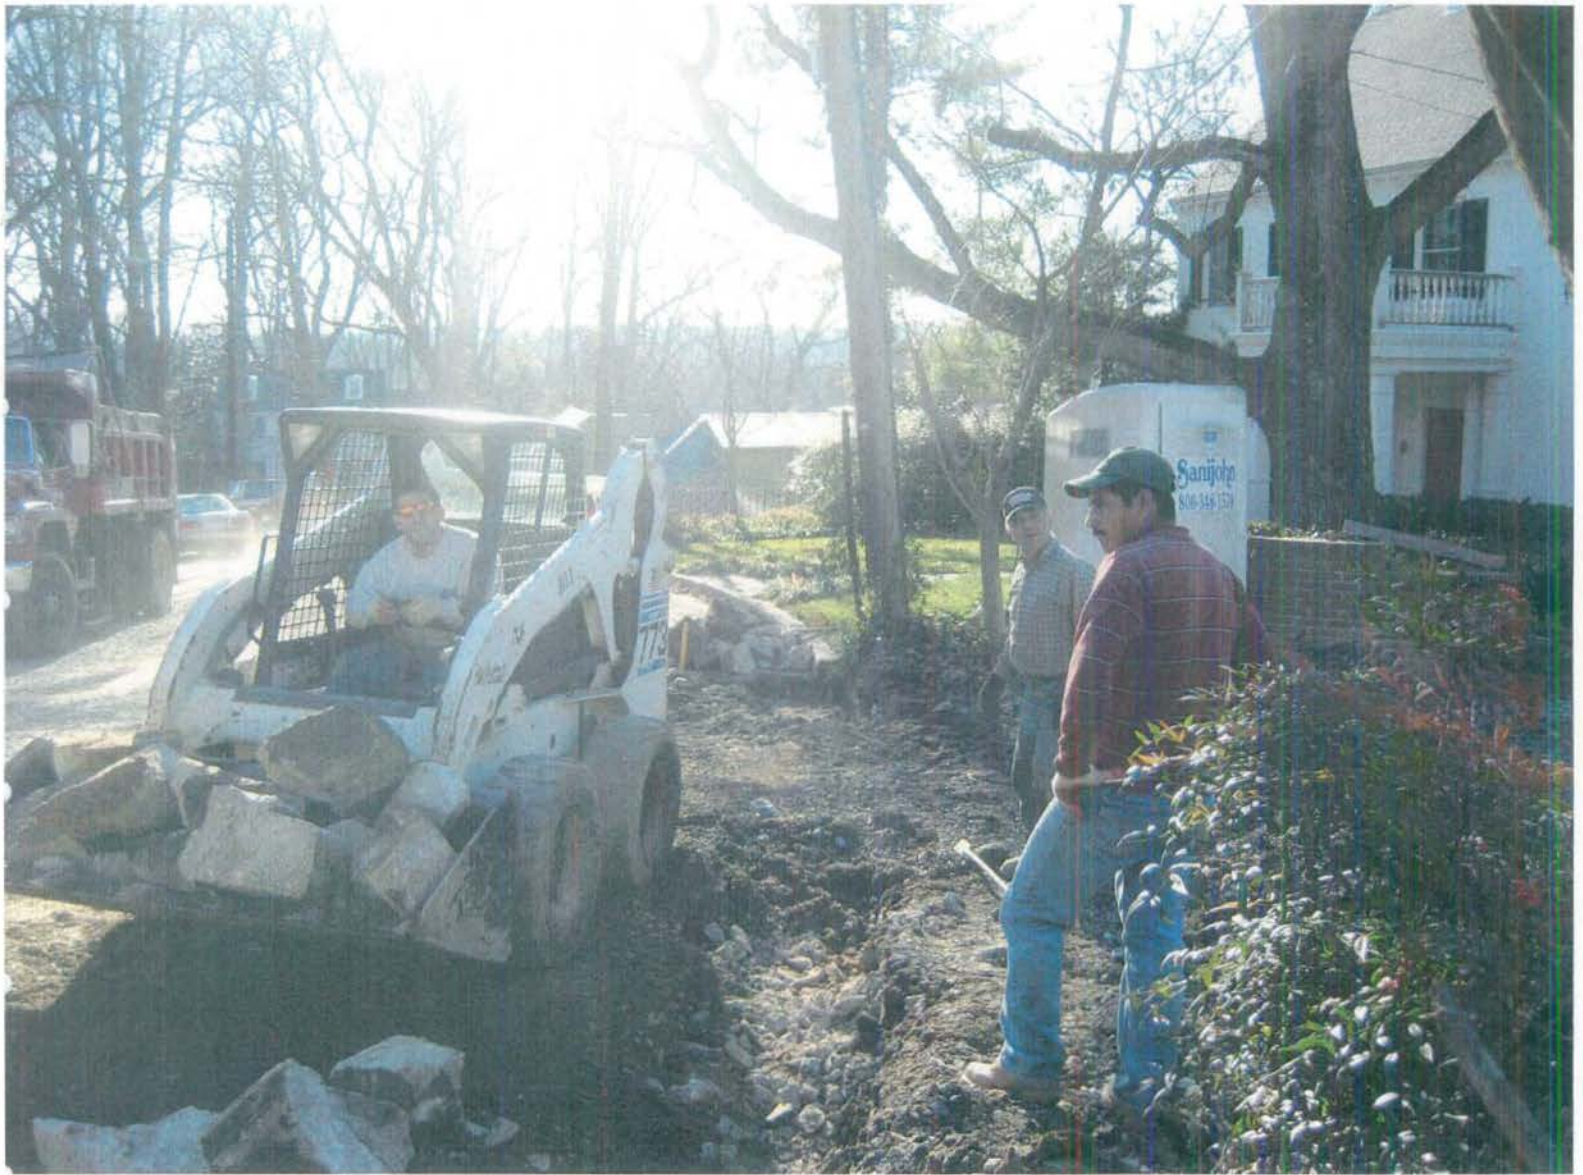
Activity during Stop Work ~~at~~ Order(s) in Nov/Dec. 2006
