McMillan Sand Filtration Plant

Historic Preservation Plan

May 2016

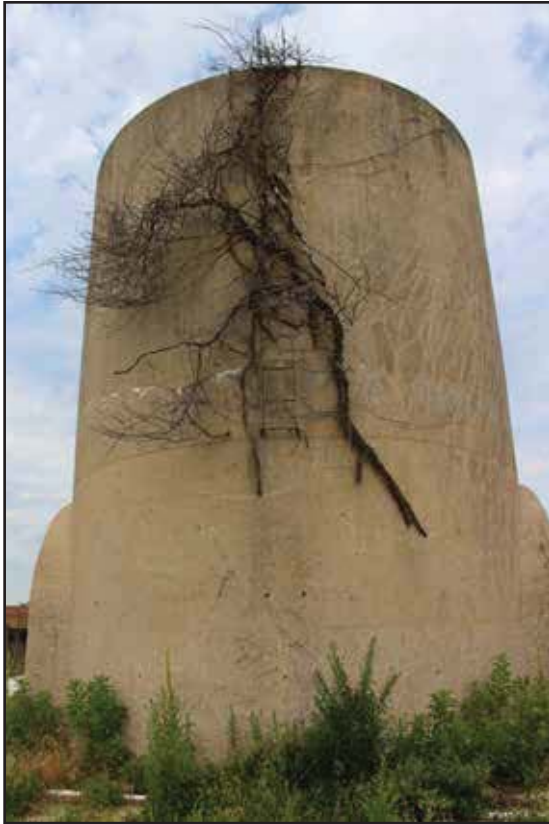
Sand bin 13, looking west. 2015.

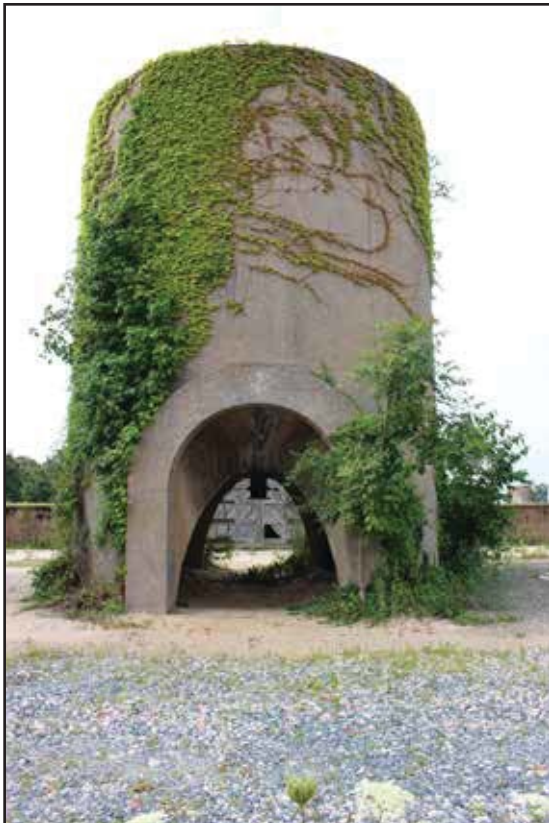
Sand bin 18, looking south. 2015.

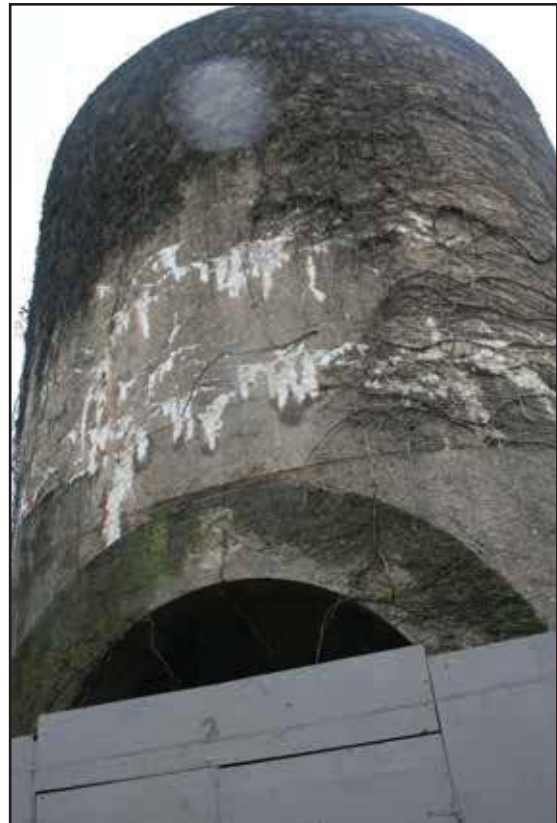
Sand bin 21, looking south. 2015.

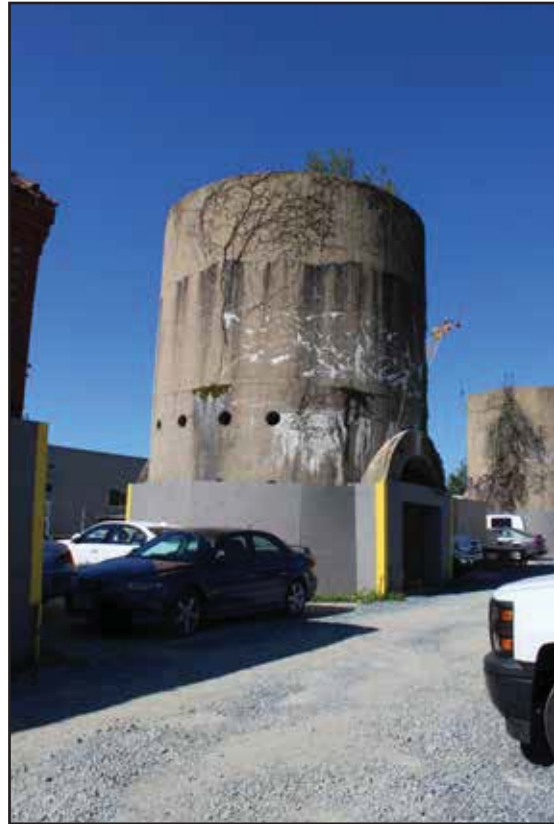
Sand bin 26, looking southwest. 2015.
